“SMART” WATER-BASED EPOXY COATINGS FOR CORROSION PROTECTION OF AA2024

- Develop more effective “smart” coatings for corrosion protection of AA2024

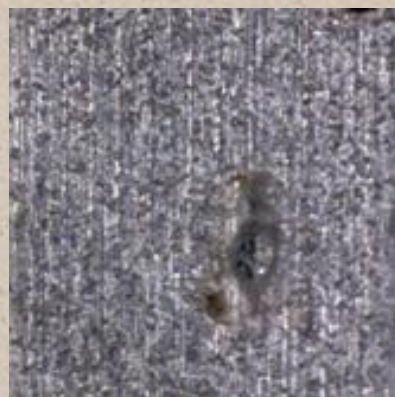
Blank coating

Scan size: W0.9 x H0.96 mm

1h \rightarrow 5.9 – 5,5

15h \rightarrow 6 – 5,3

Activity increases

1h \rightarrow -3 to 3

15h \rightarrow -6 to 6

pH map

Current map $I = \mu\text{A}/\text{cm}^2$

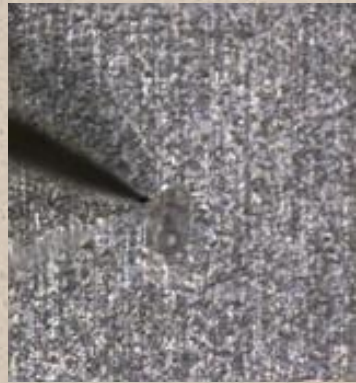
Coating + MBT filled nanocapsules

Scan size: W1.0 x H1.1 mm

1h \rightarrow 6.1 – 4.9

15h \rightarrow 6.5 – 6.2

Activity decreases

1h \rightarrow -3 to 3

18h \rightarrow -6 to 6

Activity vanishes

pH map

Current map $I = \mu\text{A}/\text{cm}^2$
